# DOCUMENTING COASTAL FLOODING & EROSION IN WESTERN ALASKA

Presentation for the Local Environmental Observer Network Monthly Webinar October 2017

State of Alaska, Dept. of Natural Resources Division of Geological & Geophysical Surveys Coastal Hazards Program Manager Photo collected by Gay Sheffield Alaska Sea Grant Nome MAP Agent, Nome, October 2016

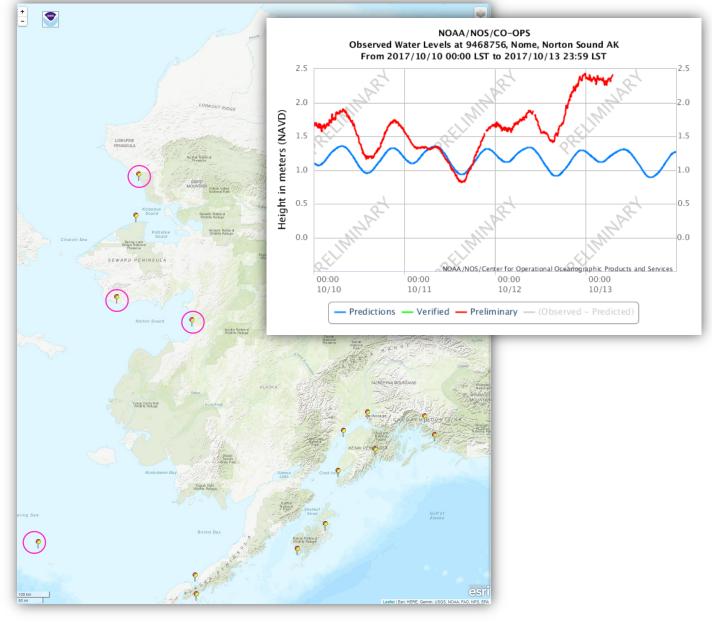
NOAA operated tide gauges
Red Dog
Nome
Unalakleet
St. Paul Island

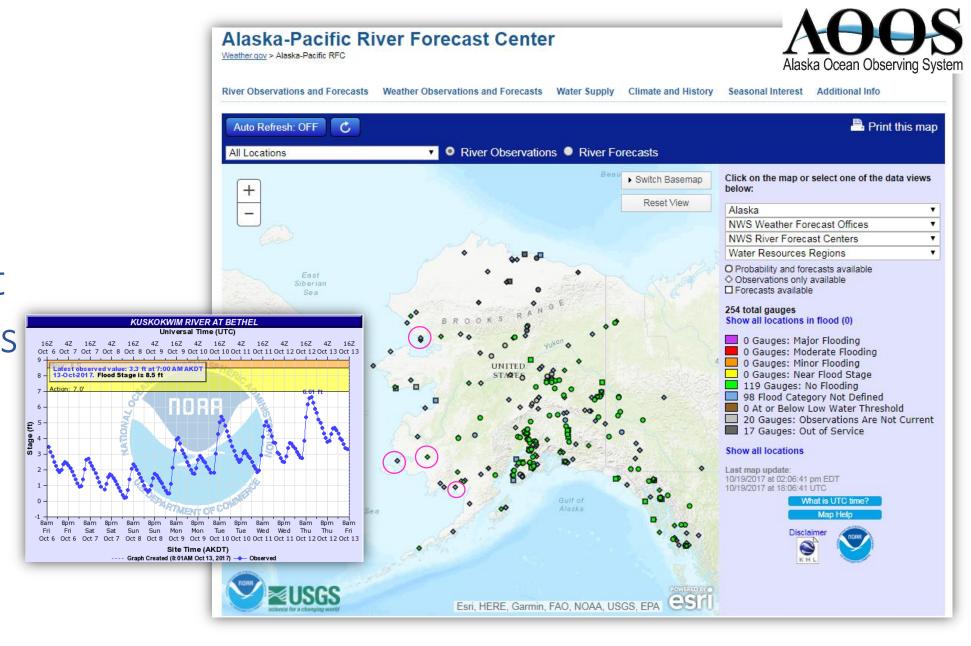
DGGS and Alaska Pacific River Forecast Center Gauges Kotzebue Tununak Bethel Dillingham coming back online

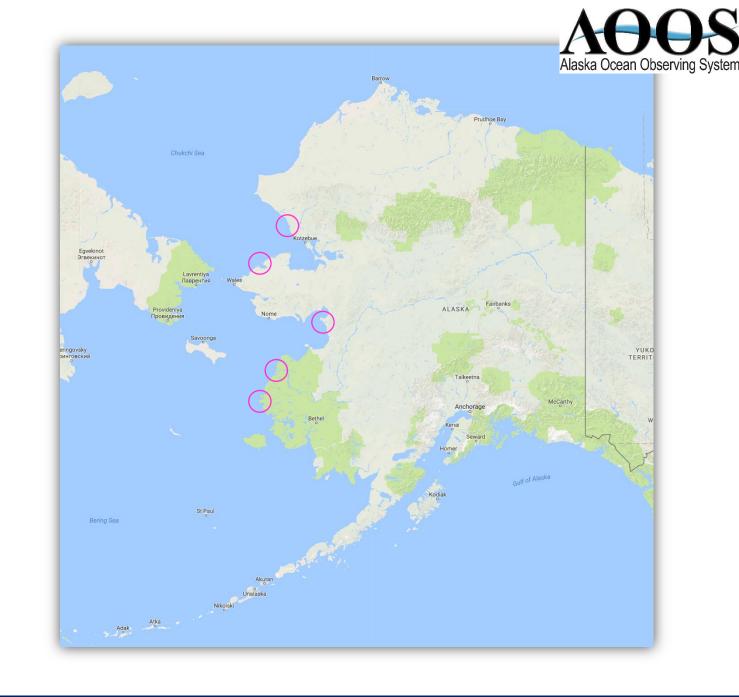
Rapid Response
Storm Sensors
Shishmaref
Kivalina
Shaktoolik

Nunam Iqua Hooper Bay

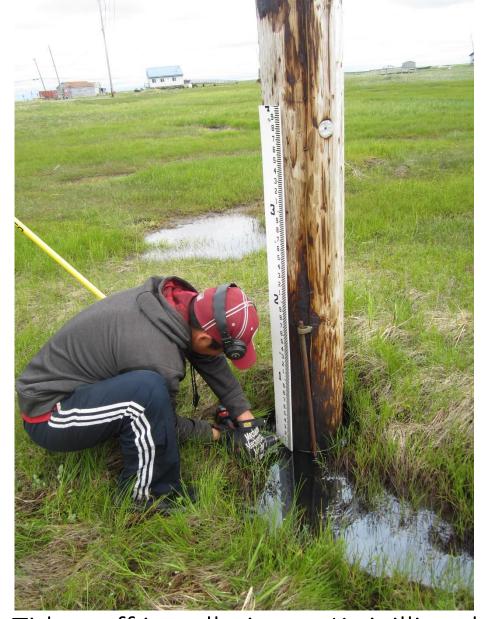
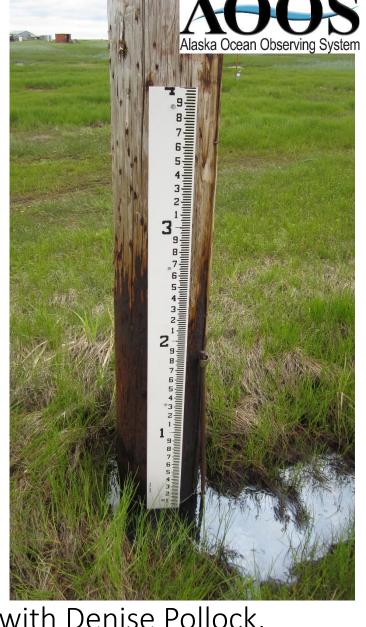
**DGGS Placed** Staffs for Community Observations Shishmaref Golovin Kotlik Chevak Kwigillingok Chignik Lake

Tide staff installation at Kwigillingok, with Denise Pollock, Lewis Amik III, and Jacquelyn Overbeck

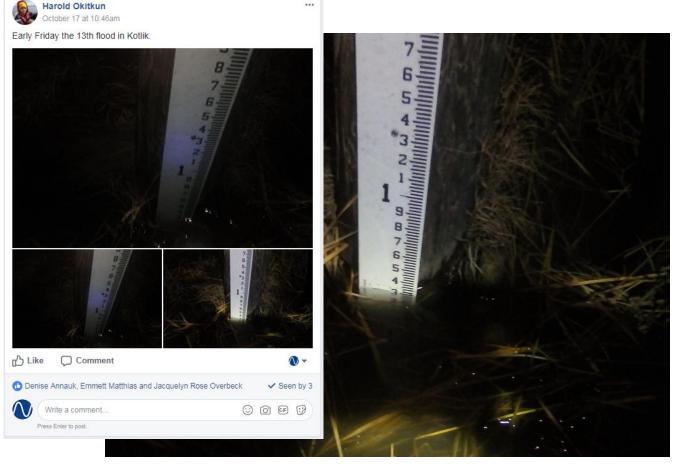
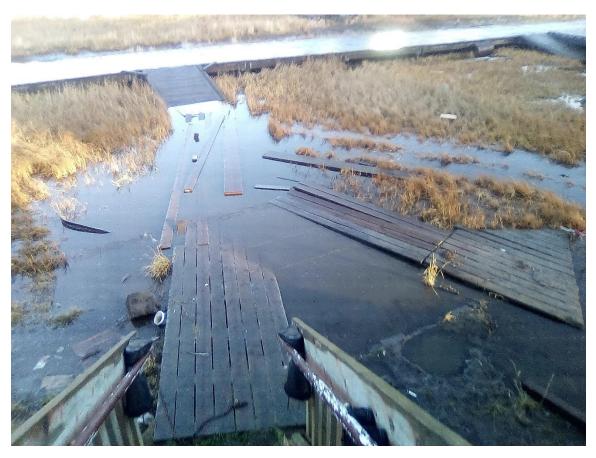
Close up photo of the tide staff and a photo showing boardwalk damage at Kotlik on October 13, 2017, taken by Harold Okitkun

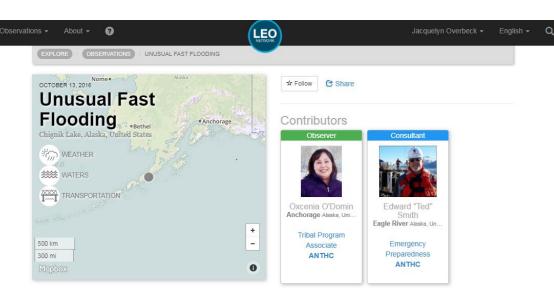
Observation: Flooding occurred unusually fast beginning on October 9th - similar to what occurred in December 2007 with heavy rain and bad weather conditions that resulted in infrastructure damage to homes and damage and washout of the road culvert that provides access for part of the community to the airport. Water levels are currently still rising on October 13th. Shared post by Oxcenia O'Domin (ANTHC-LEO), and Shalene O'Domin, local resident.

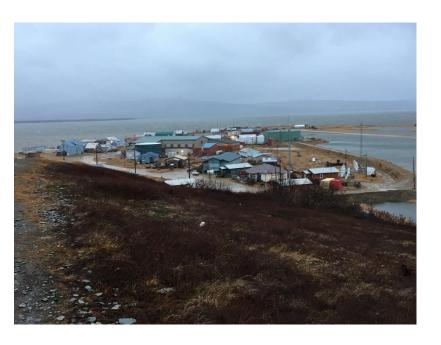
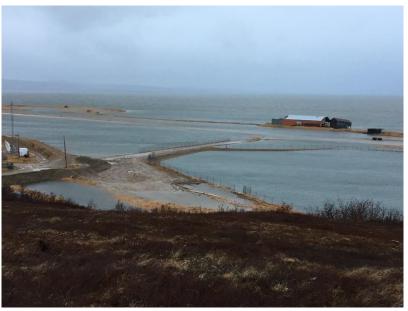
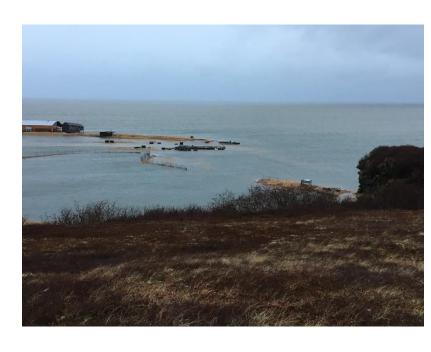
A series of photos from a high point at Golovin, taken by Toby Anungazuk Jr. on October 13.

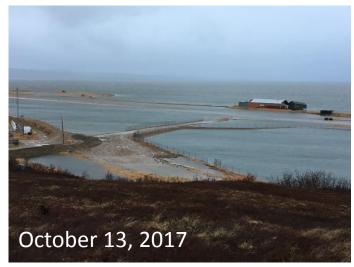
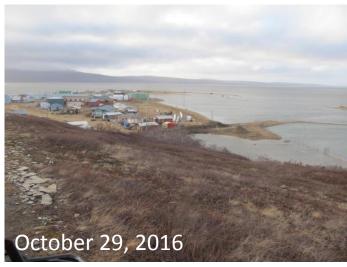
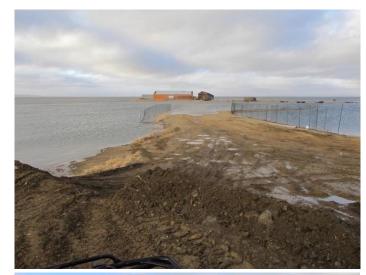
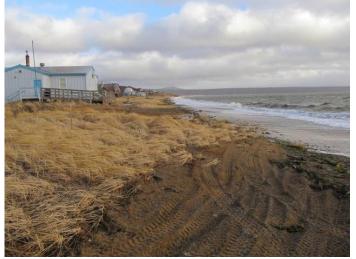
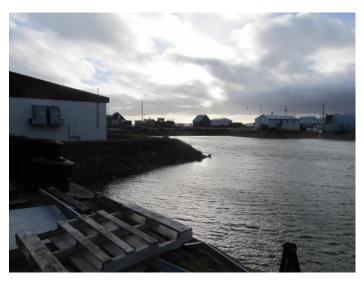
Photos taken at Golovin, October 29, 2016 by Jack Fagerstrom.

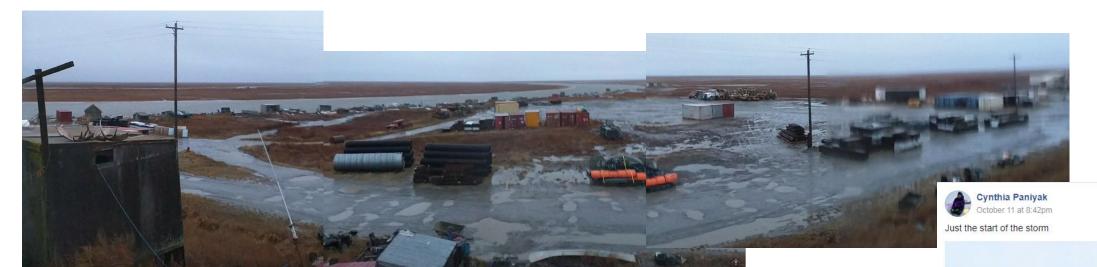
Panoramic photo taken by Cynthia Paniyak and posted to Alaska Water Level Watch Facebook page during the start of a storm on October 11 at Chevak.

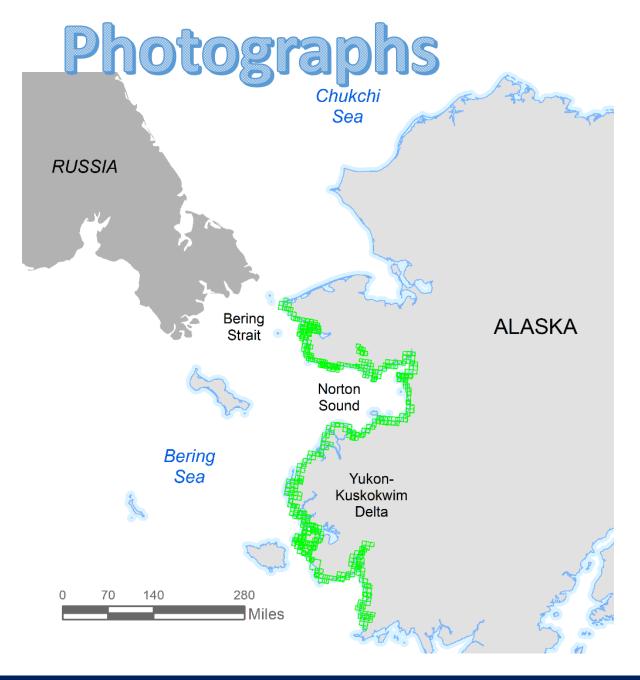
Method requires high resolution elevation and orthoimagery data, available over the areas in the map.

- 1. At the intersection of aerial photo-identifiable features,
- 2. Low-slope ground surfaces,
- 3. Even surfaces, and
- 4. Multiple exposed and sheltered coastal locations.

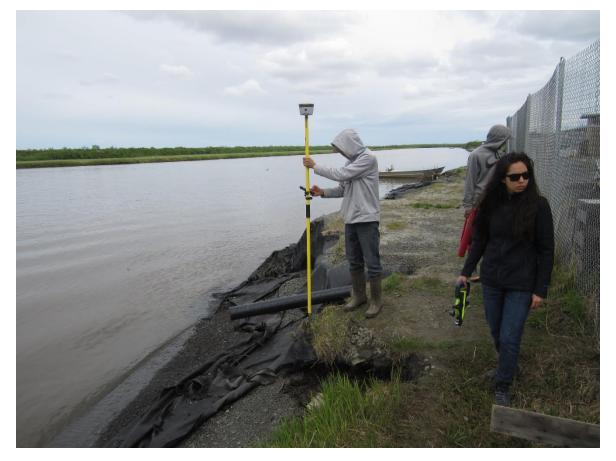
Photo from field installation of erosion monitoring equipment
